ODESSA

B. Merchant vessels noted in port

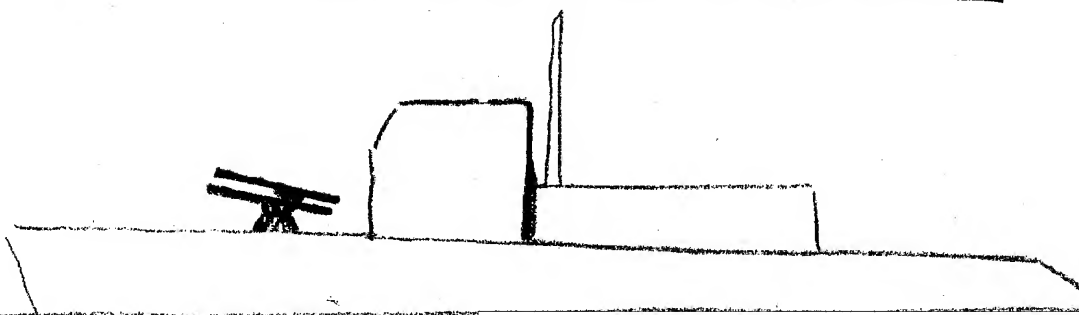
~~SECRET~~ SKETCH of MOTOR PATROL VESSEL

F. At 0800 of 13 and 14 June two motor patrol vessels of the following description were observed heading out to sea: (See sketch below.)

-- length: about 15 meters

-- breadth: about 3 meters

-- height of bow at water level: 1.5 meters

-- height of stern at water level: .8 meter

-- height of deck mast: about six meters

-- height of bridge of upper deck: about 1.9 meters

-- armament: two "Colt," single-barrel machine-guns located at bow

-- hull: iron

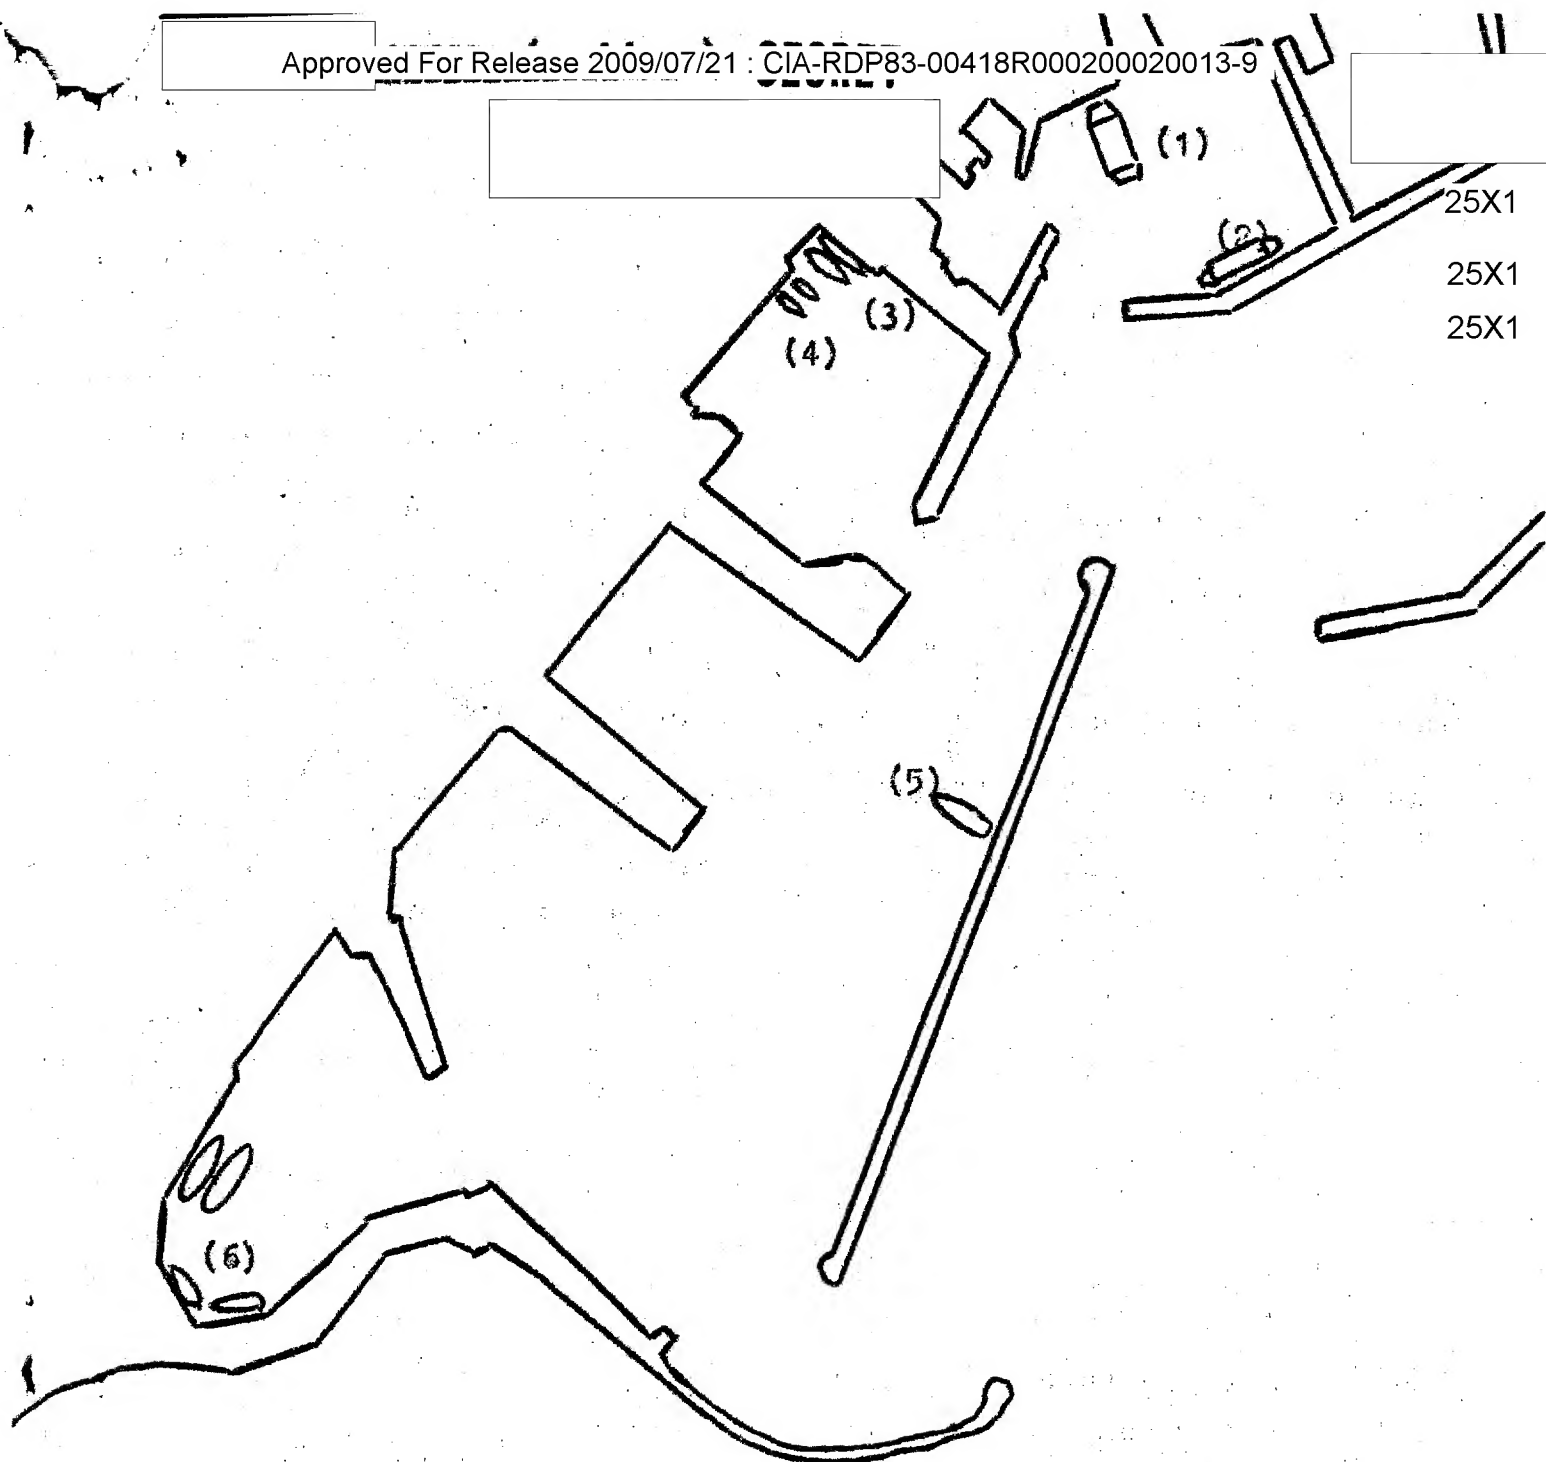
A mixed cargo ship of 12,000 tons, red-lead-painted, in the basin (1); a cargo steamer of about 6,000 tons, red-lead-painted, in the basin (2).

Observed at location (6) were four freighters apparently under-going repairs; visible on board were workers and wooden scaffolding.

(3) -- two torpedo boats

(4) -- two GIS II motor torpedo boats

- (1) **DRYDOCK**
~~Dock~~ with 12,000-ton steamship
- (2) **DRYDOCK**
~~Dock~~ with 6,000-ton steamship
- (3) Two torpedo boats
- (4) Two motor torpedo boats
- (5) Former Italian training ship
- (6) Four steamships under repair
